# Fatigue tests of welded plate girders in bending, May 1965

Progress Report on the Fatigue Strength  
of Welded Plate Girders

FATIGUE TESTS OF WELDED PLATE GIRDERS IN BENDING

Fritz Engineering Laboratory Report 303.9

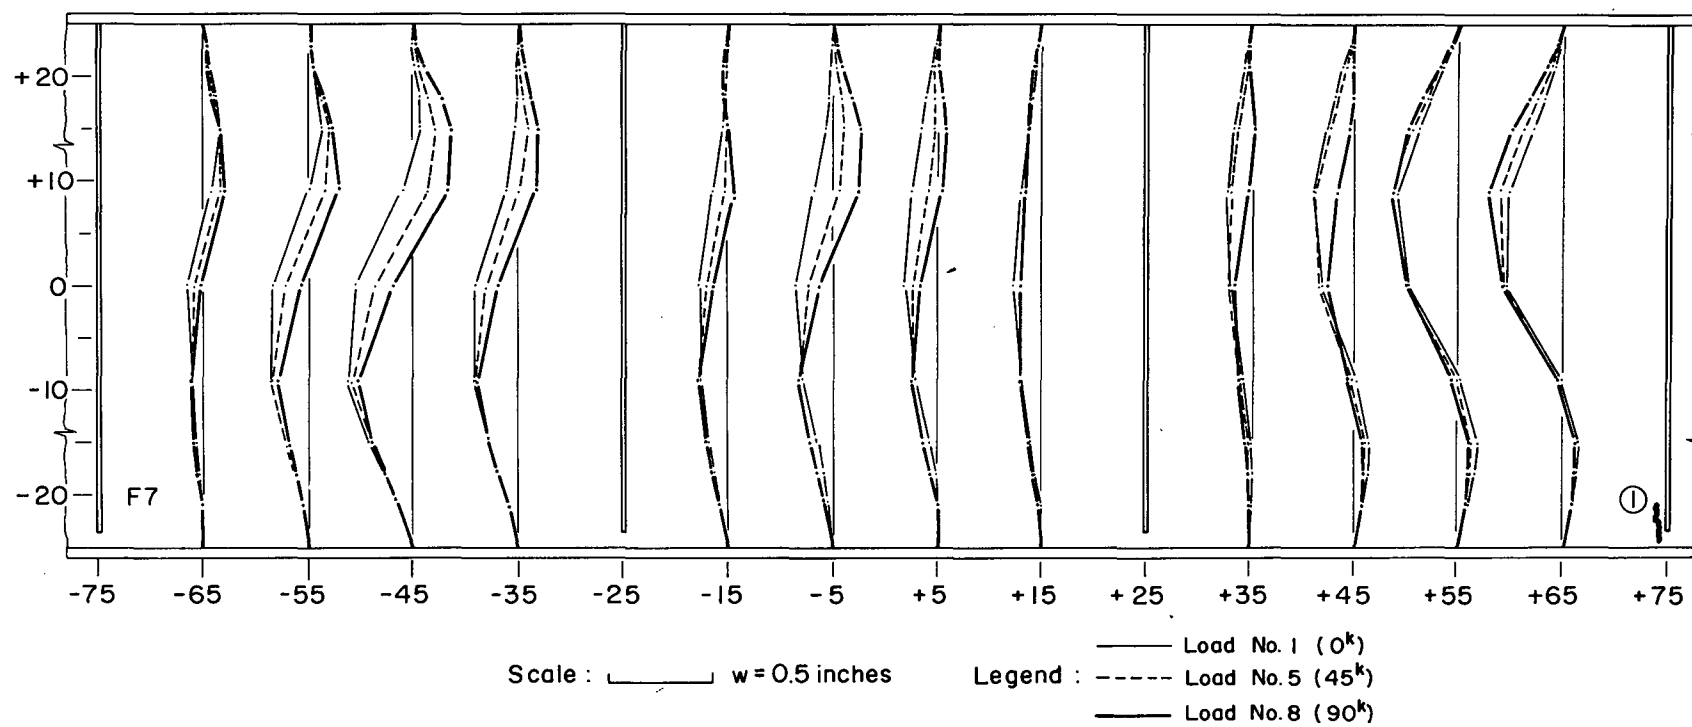
Fig. 9 Web Cross-Sectional Shapes, Girder F7

For a description of the web cross-sectional shapes, reference is made to those for girder F7, Fig. 9. An outline sketch of the test section is shown together with the x and y coordinates. The shapes for loads of

From Fig. 9, it can be seen that large relative lateral deflections between zero and maximum load occurred in the compression zone of the web, while the corresponding deflections in the tension zone were quite small. Deflection patterns of this type can be considered to be a common occurrence for girders in bending as evidenced by results of these and previous tests.<sup>(4)</sup> The magnitudes of the relative deflections (from 0 to 90 kips) in the compression zone of F7 were in the order of the web's thickness (3/16").

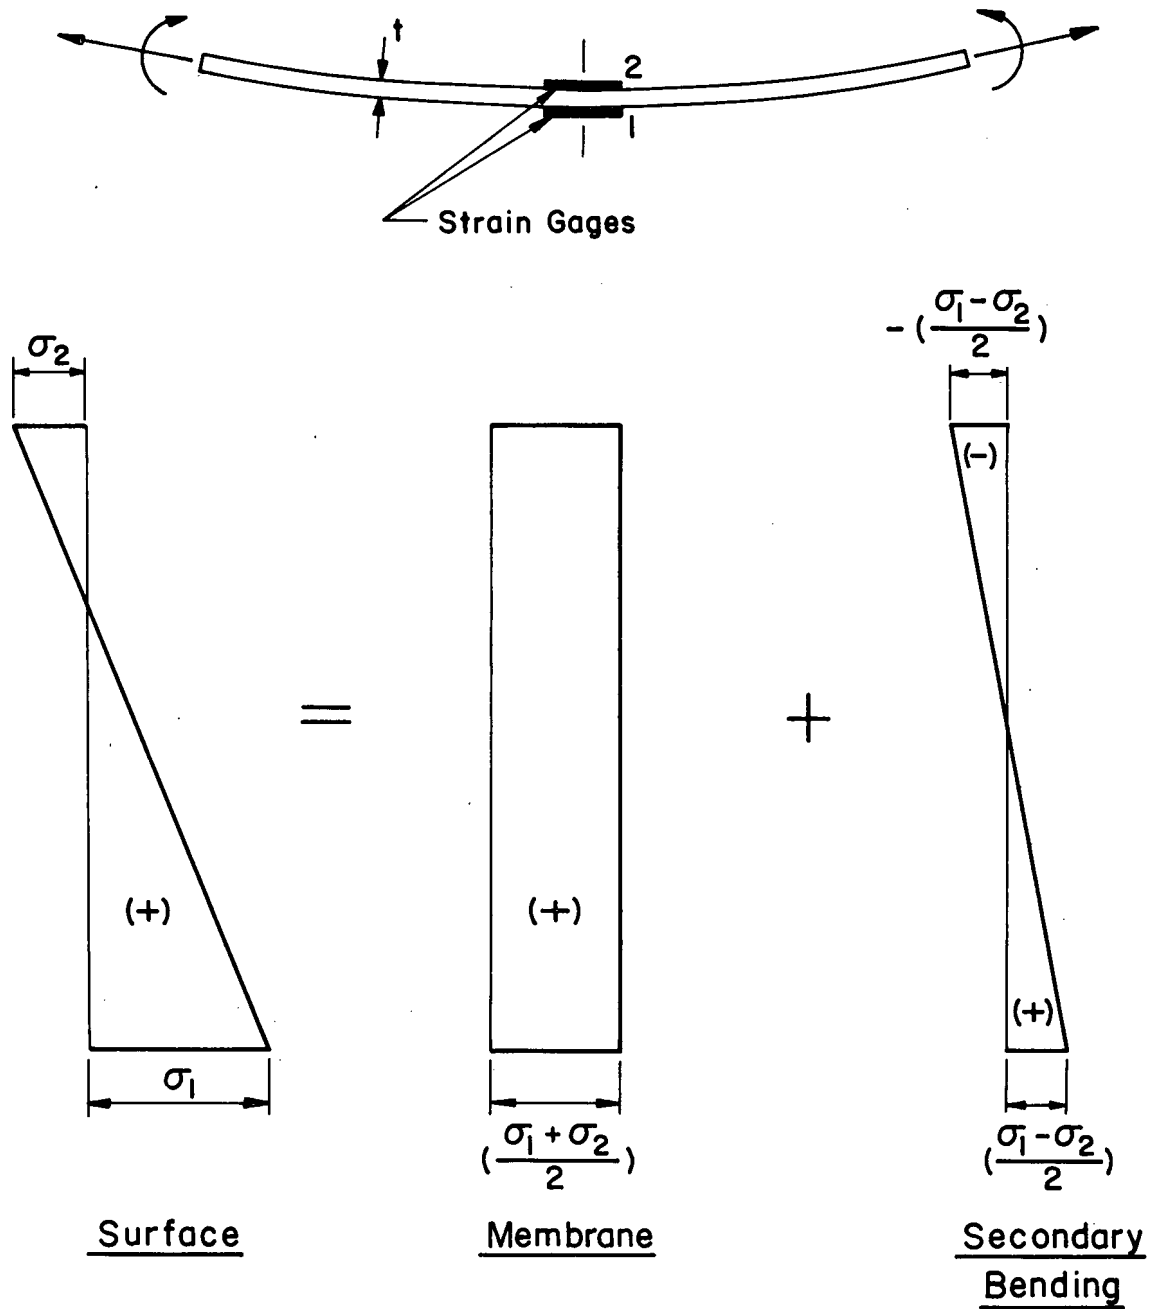
Fig. 13 Components of Surface Stress

By knowing the values of these surface stresses at various points on both the near and far side of the web, it was possible to decompose the surface stress into component parts, that is, into membrane and secondary bending stress. The membrane stress results primarily from bending of the girder in its plane, and is considered to be distributed uniformly across the thickness of the web. Secondary bending stress, also referred to as plate bending stress, is caused by the lateral movement of the web. This component of the surface stress has a linear distribution across the web's thickness as indicated in Fig. 13.

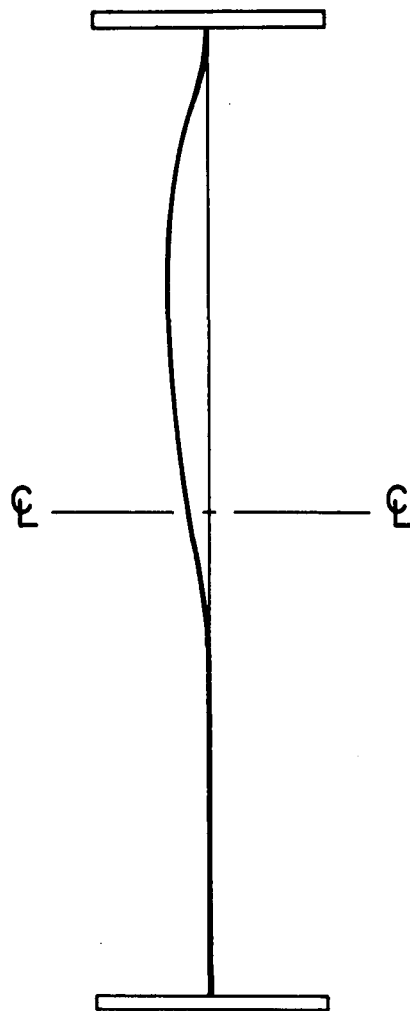
Fig. 18 Typical Web Deflection

The results from the web deflection measurements agreed very well with what was expected. Large lateral deflections occurred in the upper portion of the web, whereas below the girder's neutral axis the web deflections were small. This common deflected configuration for girders in bending is shown in Fig. 18. For fatigue loading between two load levels, the web fluctuates between two similar deflection configurations; thus the relative movement could also be closely approximated by the deflected shape in Fig. 18. If repeated relative web deflections were the sole cause of fatigue cracks in girders subjected to bending, cracks would form in the upper region of the web, parallel to the boundaries. However, this was not the case. Three of the four primary cracks (Cracks 2 and 3, F6 and Crack 1, F7) formed in the lower part of the web where there was little or no web deflection. Only the fourth primary crack (Crack 1 of F6) formed in a section of the web which had noticeable lateral deflection, but was below the neutral axis of the girder, not above. The success of the repair

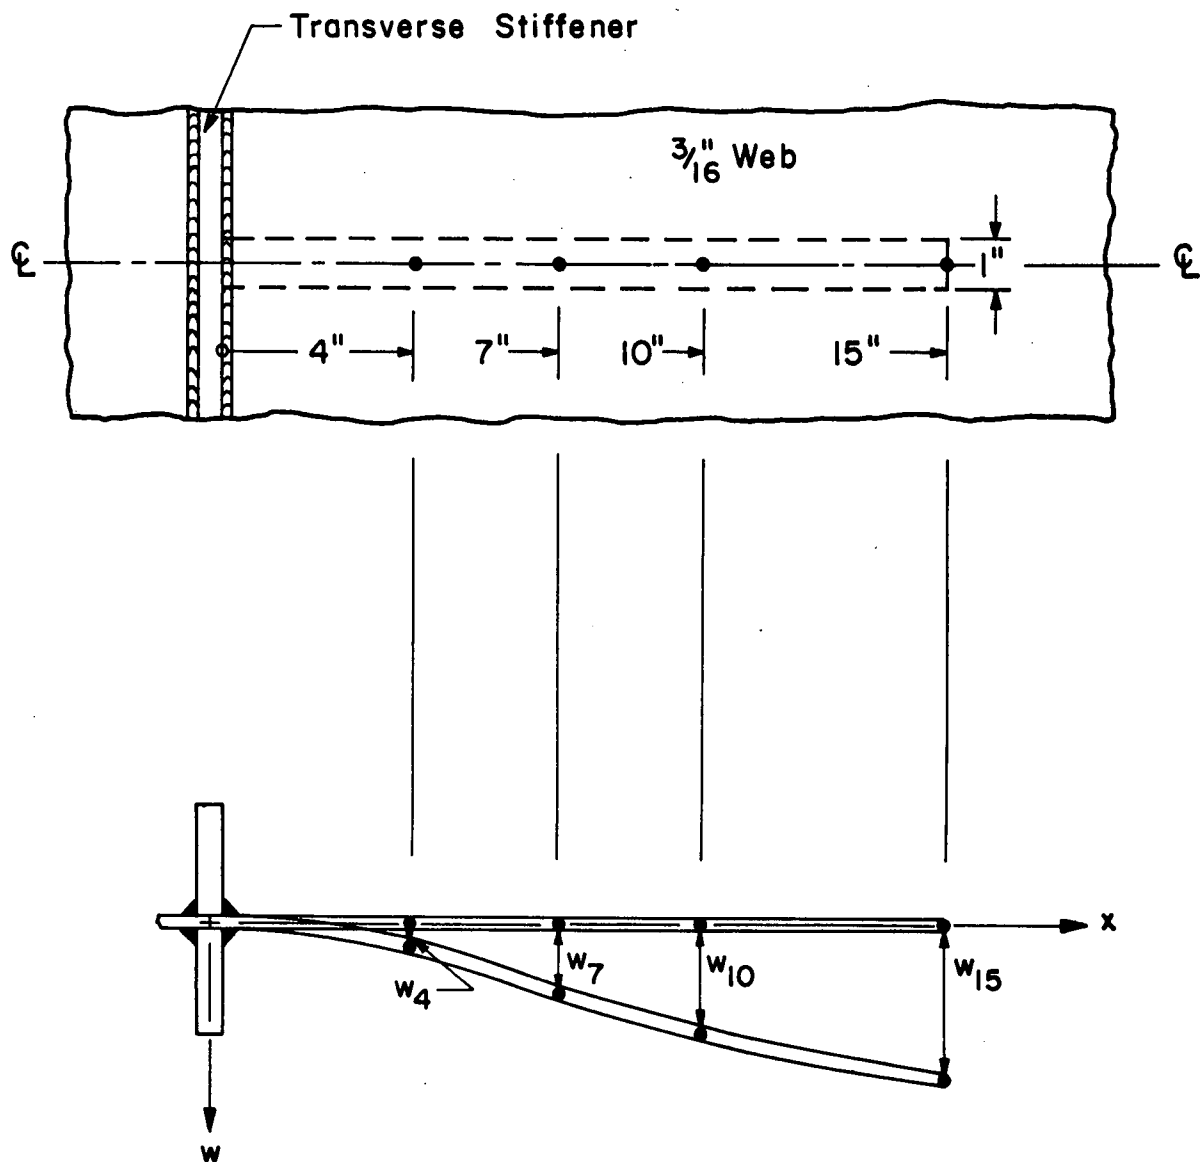
Fig. 19 Approximate Cantilever Strip

By considering an imaginary cantilever strip of unit width and using measured web deflections, as indicated in Fig. 19, a deflected shape of the web could be obtained in the form,
